Manhole Inspection Summary

Manhole # S29MM_015MH

Location Address: **2136 MOUNT ROYAL TERR** Cross Street: **NEWINGTON AVE**

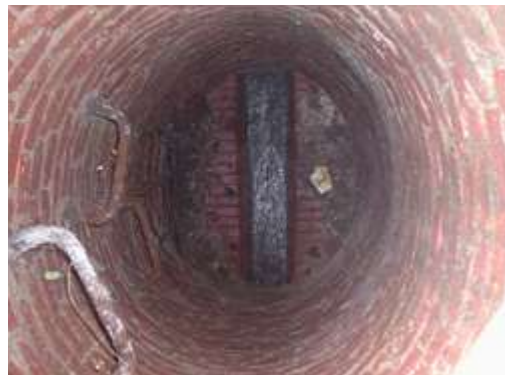
Top View

Corroded steps. Evidence of surcharge - Bench debris.

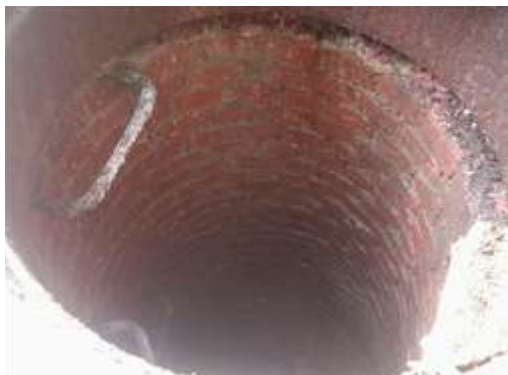
Defect

Frame offset. Adjustment deterioration and infiltration.

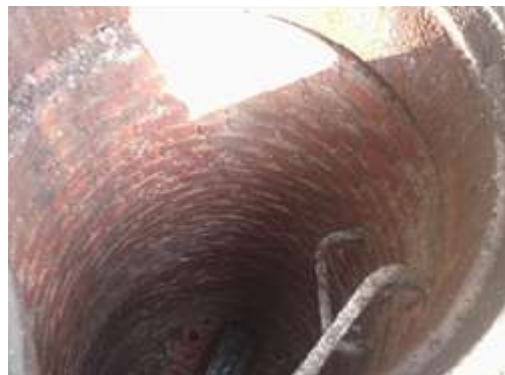
Defect

Adjustment deterioration, root intrusion and infiltration. Corbel root intrusion and infiltration. Barrel infiltration.

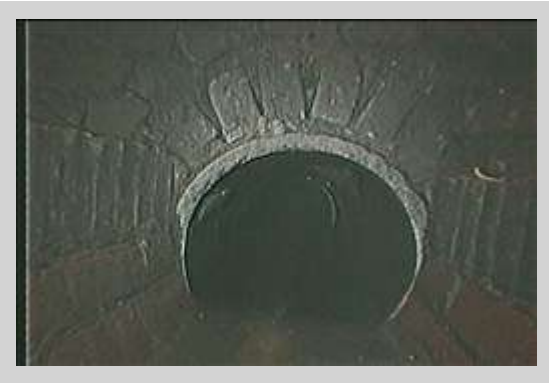
12 in. Circular Gravity Sewer Pipe Out @ 12 O'Clock

Barrel deterioration, root intrusion and infiltration. Channel deterioration.

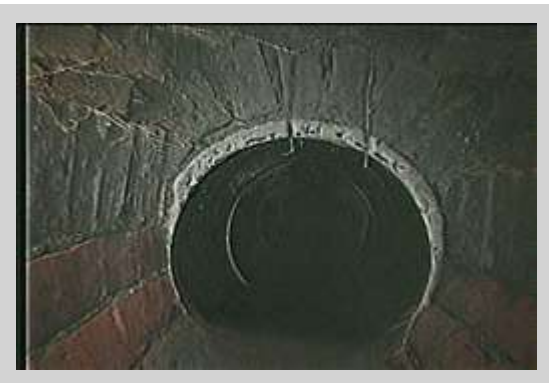
12 in. Circular Gravity Sewer Pipe In @ 6 O'Clock

Barrel deterioration, root intrusion and infiltration. Channel deterioration.
